Perforated Cor-Ten plates

ELDHEIMAR
GOSMYNJASAFN
ÚTVEGGJAKLÆÐNING
GATAÐAR PLÖTUR
VESTURHLIÐ

VERKFANG 0436-2 TEIKNING 162

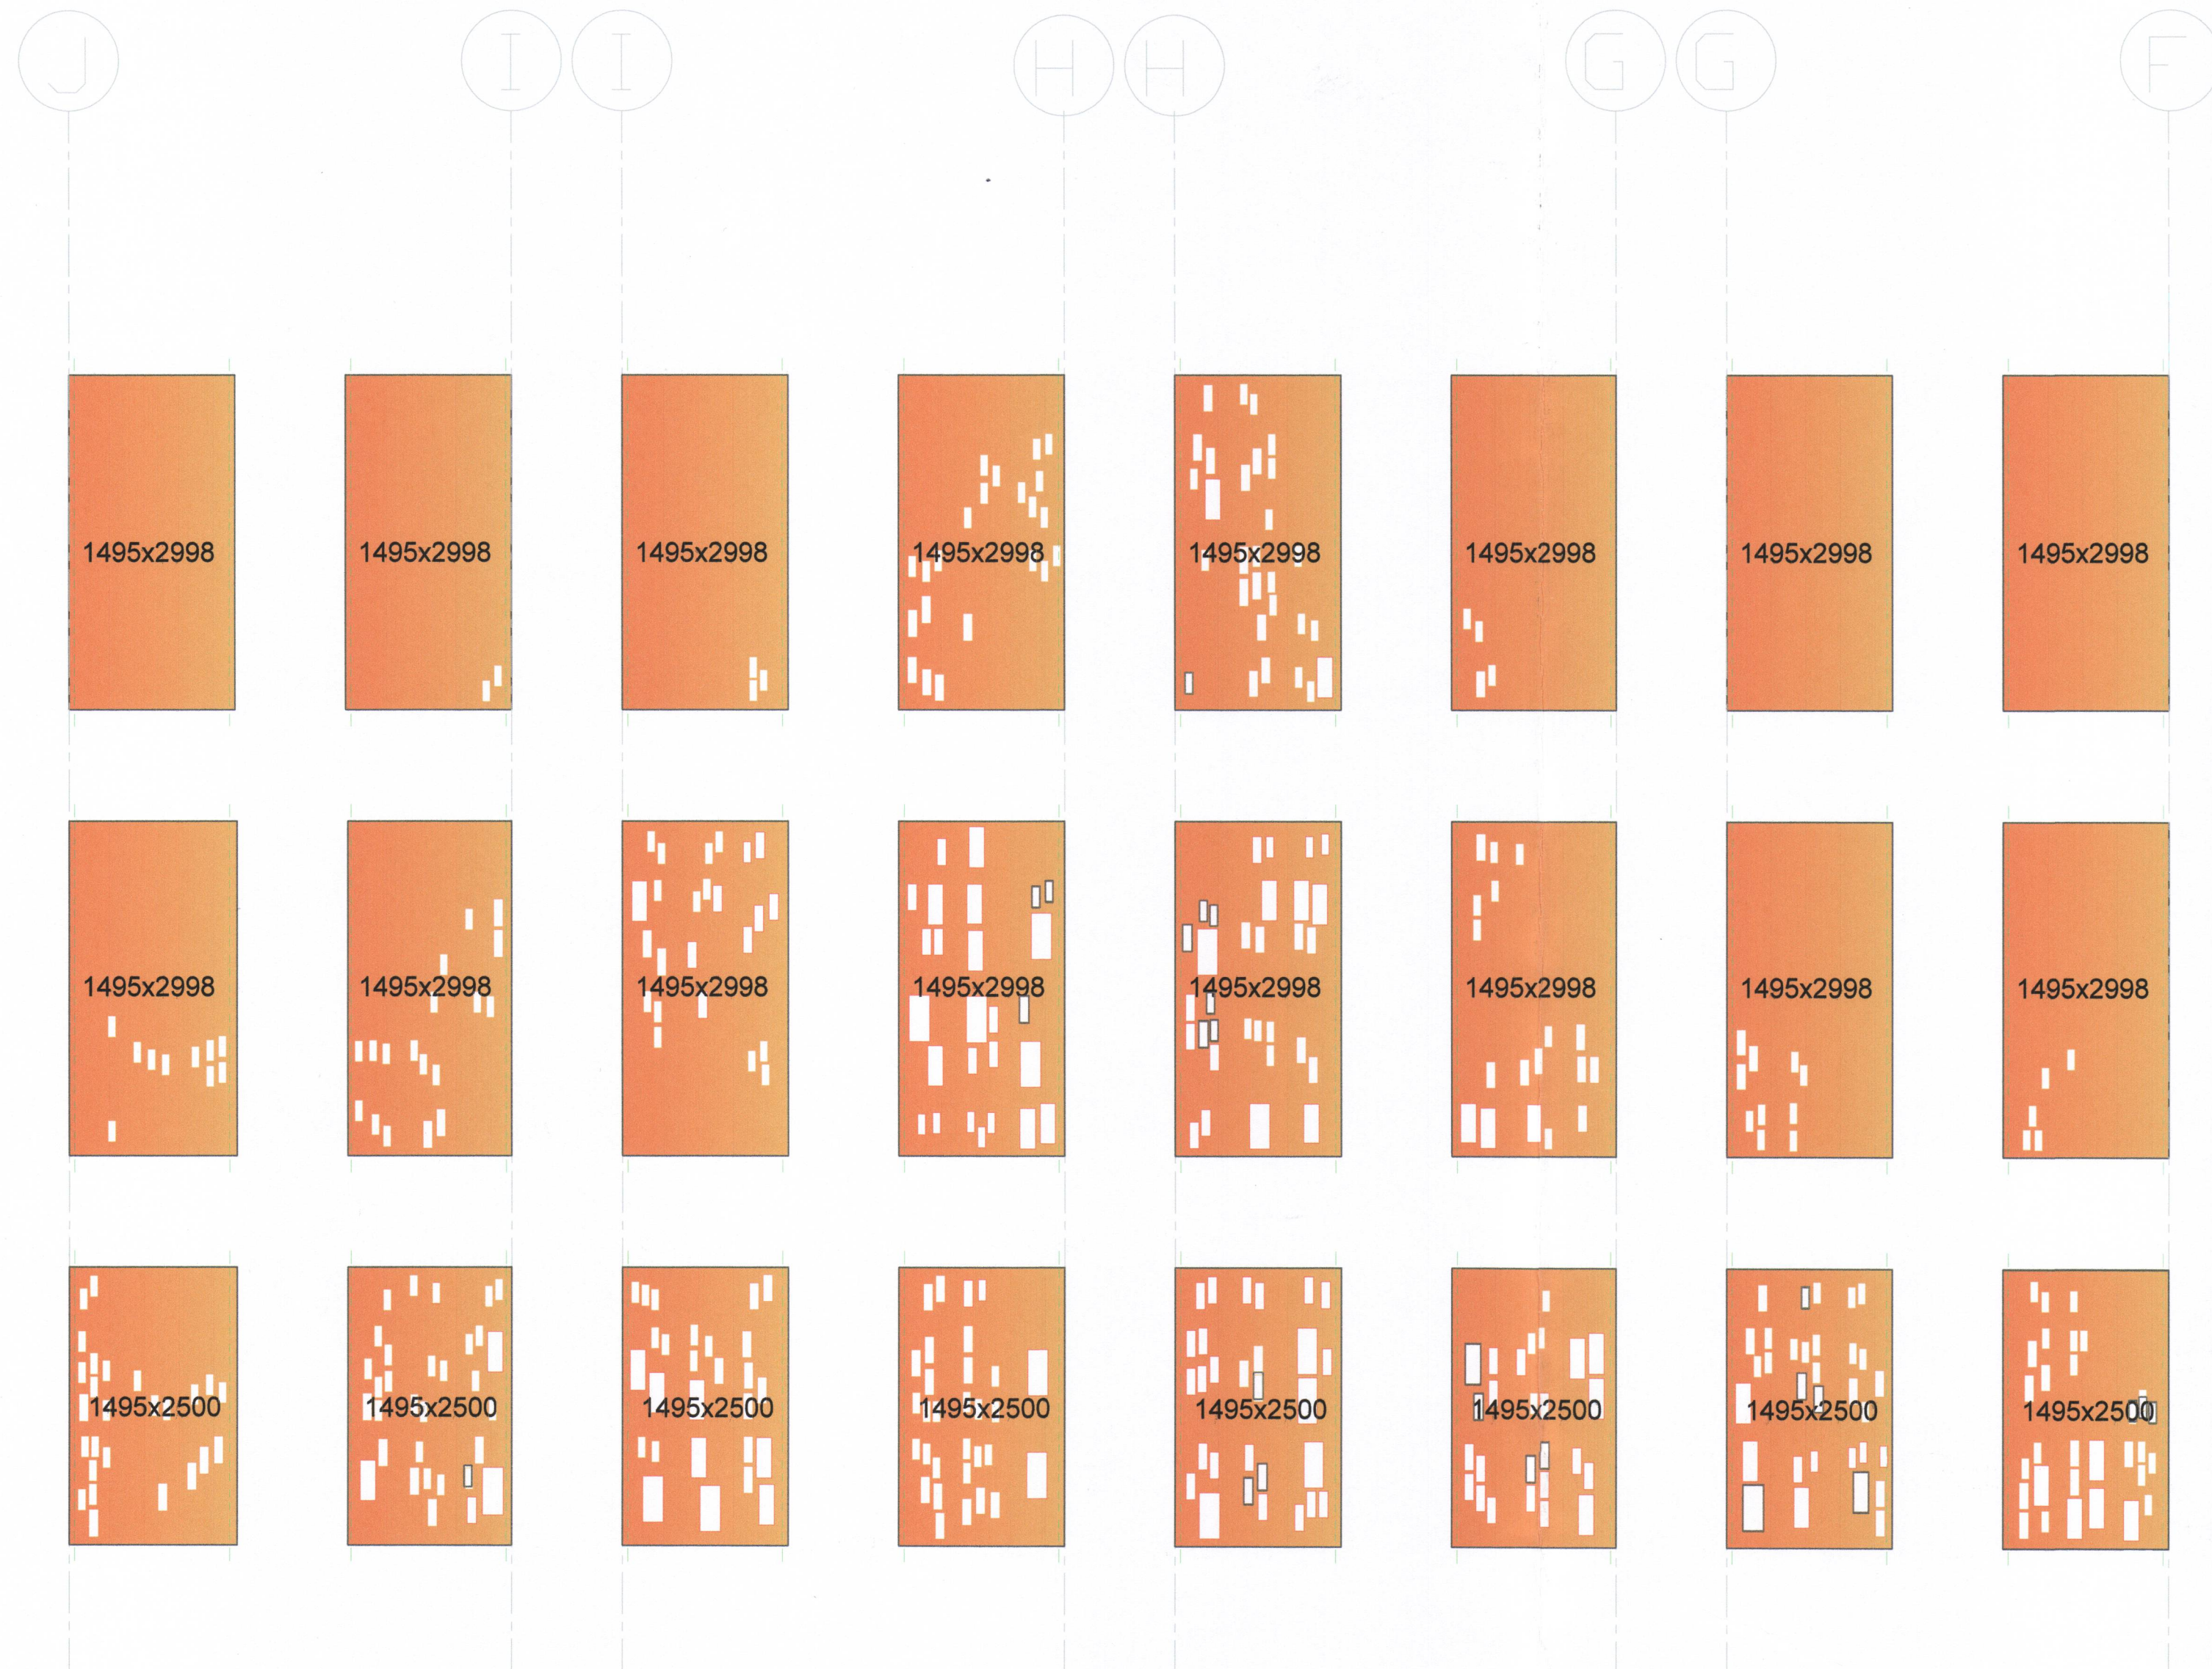
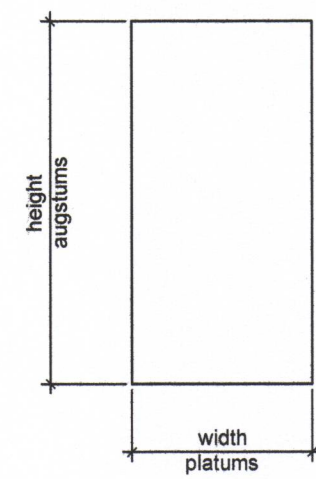
Measurements are given in mm
width x height
platum x augstums
joint between plates - 5mm
